Manhole Inspection Summary

Manhole # S21GG_028MH

Insp Date: **6/14/07 1:06 PM**

Location Address: **1840 PRESSTMAN ST**

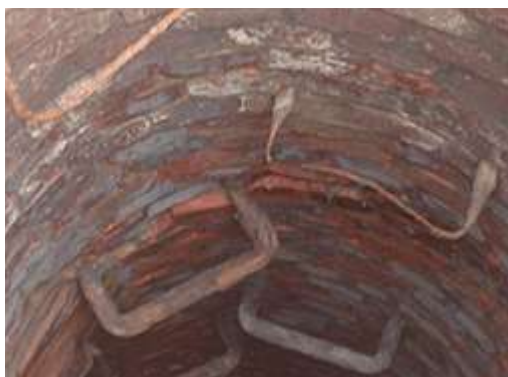
Defect 3

Condition: ☐ Sound ☐ Cracked ☐ Root Intrusion ☐ Loose Brick ☒ **Deteriorated**

DETERIORATION OF CORBEL NEAR STEP

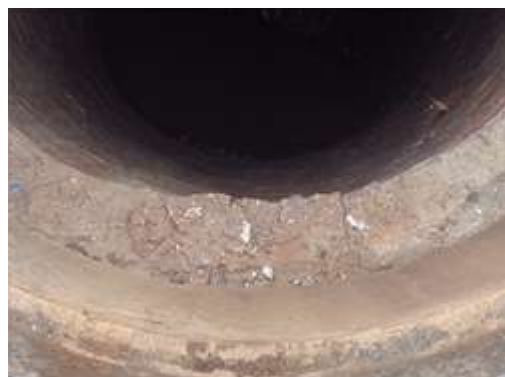
Defect 2

Offset: **3** (in.)

FRAME OFFSET

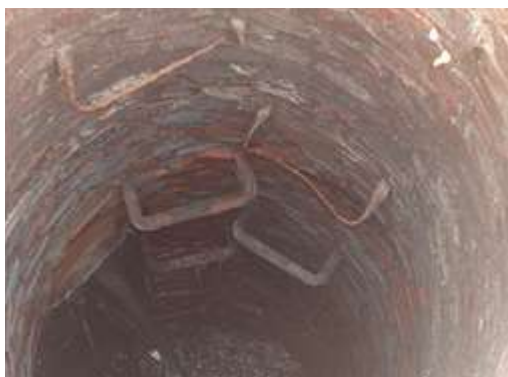
Defect 1

Count: **9** Missing: **2** ☒ **Corroded**

CORRODED AND MISSING STEPS
